MM-2001 PINSETTER

**Adjusting the pin elevator drive chain.***December 1995 (revised February 2003)*

Fenix Service Bulletin Number MM-001

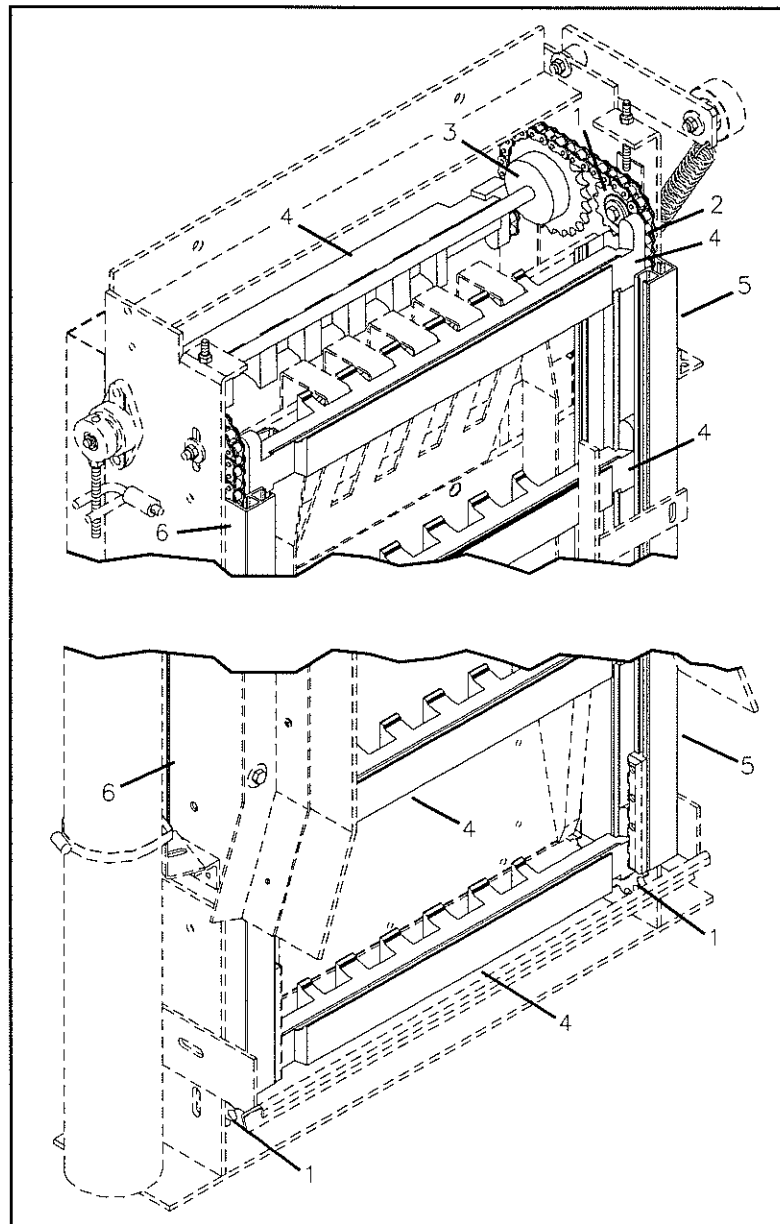
Failure to adjust the elevator's drive chain correctly will result in premature wearing of the elevator's left and right aluminum frame plates.

The elevator drive chain maintains tension on the pin lift arms. If the chains become too loose, the pin lift arms will come in contact with the aluminum frame plates at the top and bottom of the elevator. When this happens you can hear a knocking sound each time a pin lift arm makes it 180° turn at the top or bottom of the pin elevator.

The elevator's drive chain [adjustment number 5A] must be verified on a weekly basis during the first three months of operation. After the pinsetters have run for approximately three months, you may only need to verify this adjustment on a monthly basis.

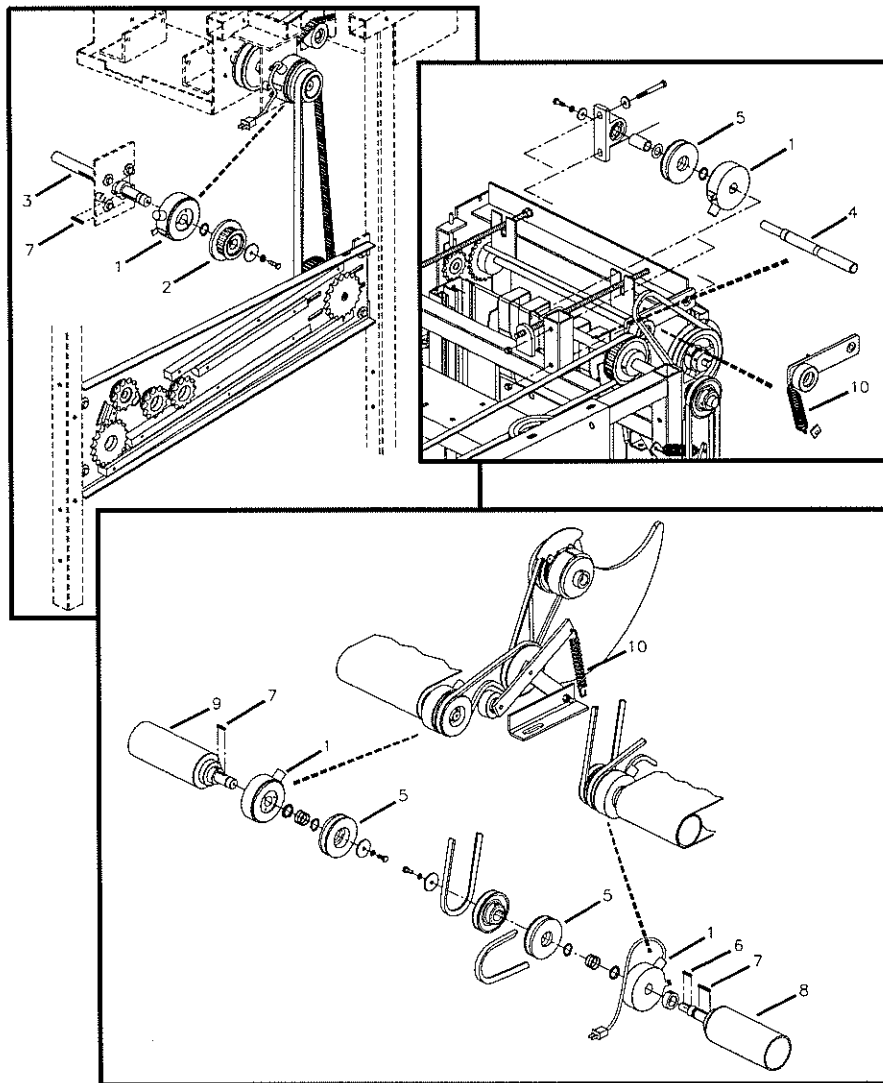
Fenix Service Bulletin Number MM-002

Cleaning and lubrication of the magnetic clutch assemblies and their partners (timing gear or pulley) is critical to proper pinsetter performance and must be performed on a bimonthly basis (every two months). Failure to have clean, well lubricated clutch assemblies will result in sweep jams, elevator jams and ball jams accordingly.

The constant friction on the coupling disk causes small dust-like particles to form a deposit on the clutch's facing.

The different clutch assemblies should be removed from the pinsetter and cleaned on a quarterly basis. The assemblies should be cleaned with a solvent such as a paint thinner. The assemblies should then be dried using a clean towel. The shaft of the machine where the clutch assembly is normally inserted should also be cleaned with a clean rag while the clutch assembly is out being cleaned as per the above.

To remove the clutch assemblies, you must first remove the corresponding belt which the assembly drives. The sweep's belt may be removed by loosening the three bolts which hold the sweep drive channel in place. The ball door's belt may be removed by simply removing the spring as shown in the diagram. The same method is also used for the elevator's belt.

Following re-assembly of the sweep drive clutch assembly, make sure to re-adjust the tension on the timing belt as explained in adjustment 2E. The other clutch assemblies need only to have the spring replaced in order to re-establish tension on the belt.

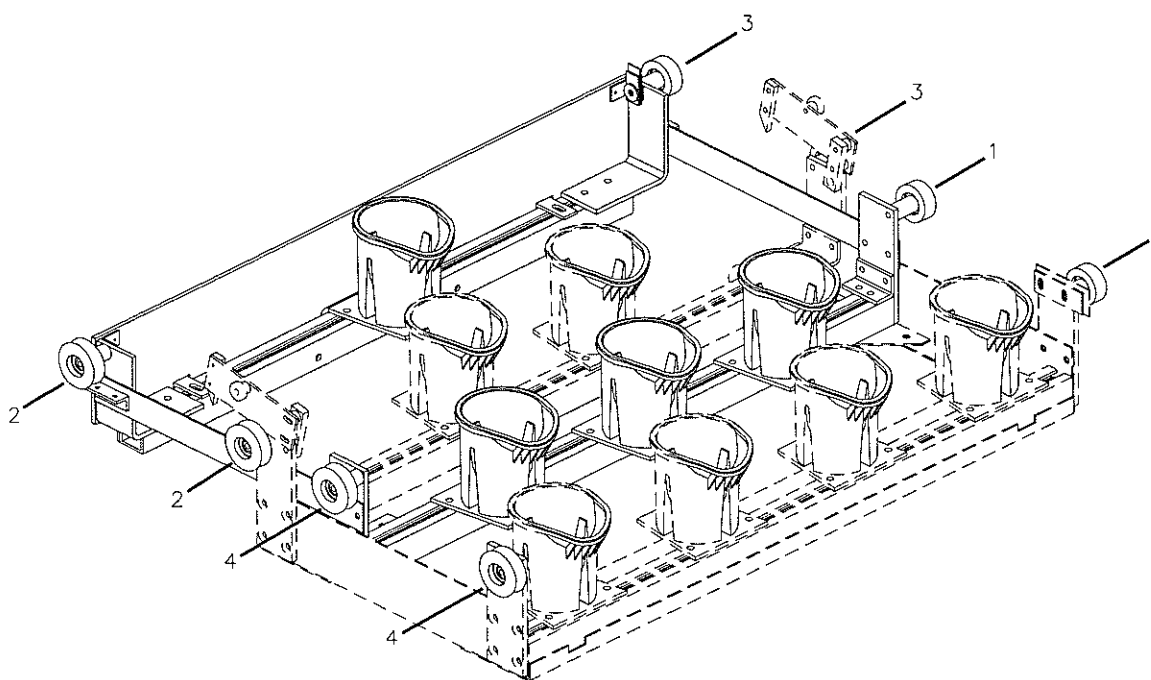
Fenix Service Bulletin Number MM-004

The two rear plastic guide rollers (303-3300-00) have been replaced by aluminum (308-3300-00) ones.

The two rear plastic guide rollers used on the right side of the drawer have a tendency to break due to the impact caused by the pins when the magazine loads the drawer's row of seven.

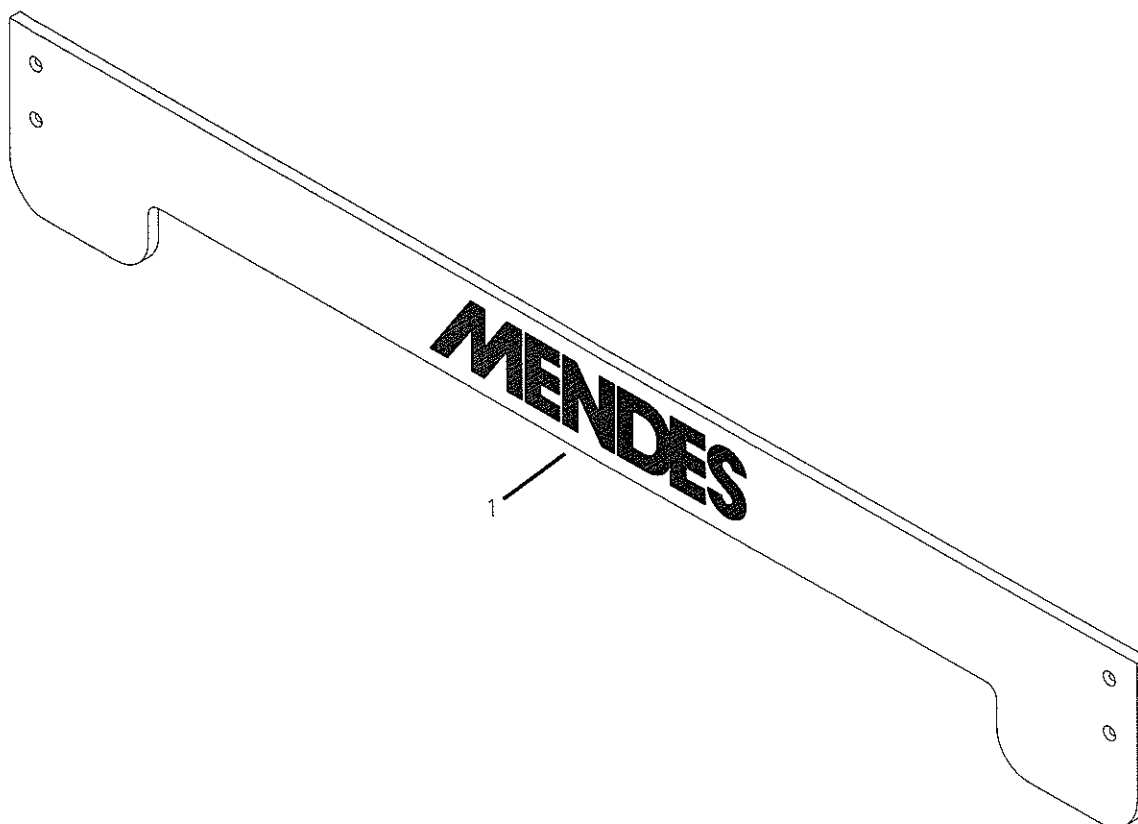
Fenix Service Bulletin Number MM-005

In all of these cases it has been found that extra weight has been added to the sweep boards.

The sweep board is an integral part of the MM-2001 pinsetter and was designed to perform its task of removing deadwood from the lanes with the greatest ease and the least amount of wear to the pinsetter itself. At no time should additional weight be affixed to the sweep board (e.g. publicity panels) since this will greatly reduce the life expectancy of all moving parts pertaining to the sweep and at the same time will void the Fenix Warranty.

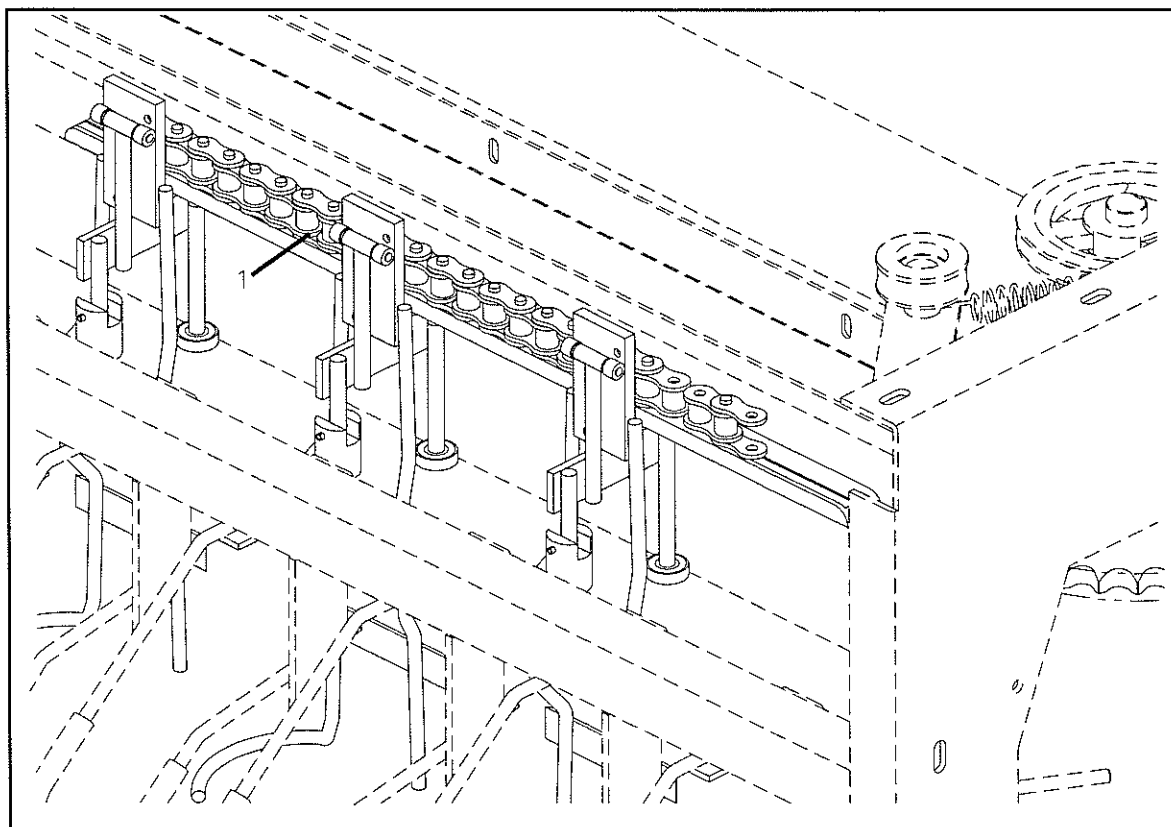
Fenix Service Bulletin Number MM-006A

The jerky movement of a badly lubricated carrousel drive chain will inevitably cause problems and greatly reduce the parts' life expectancy.

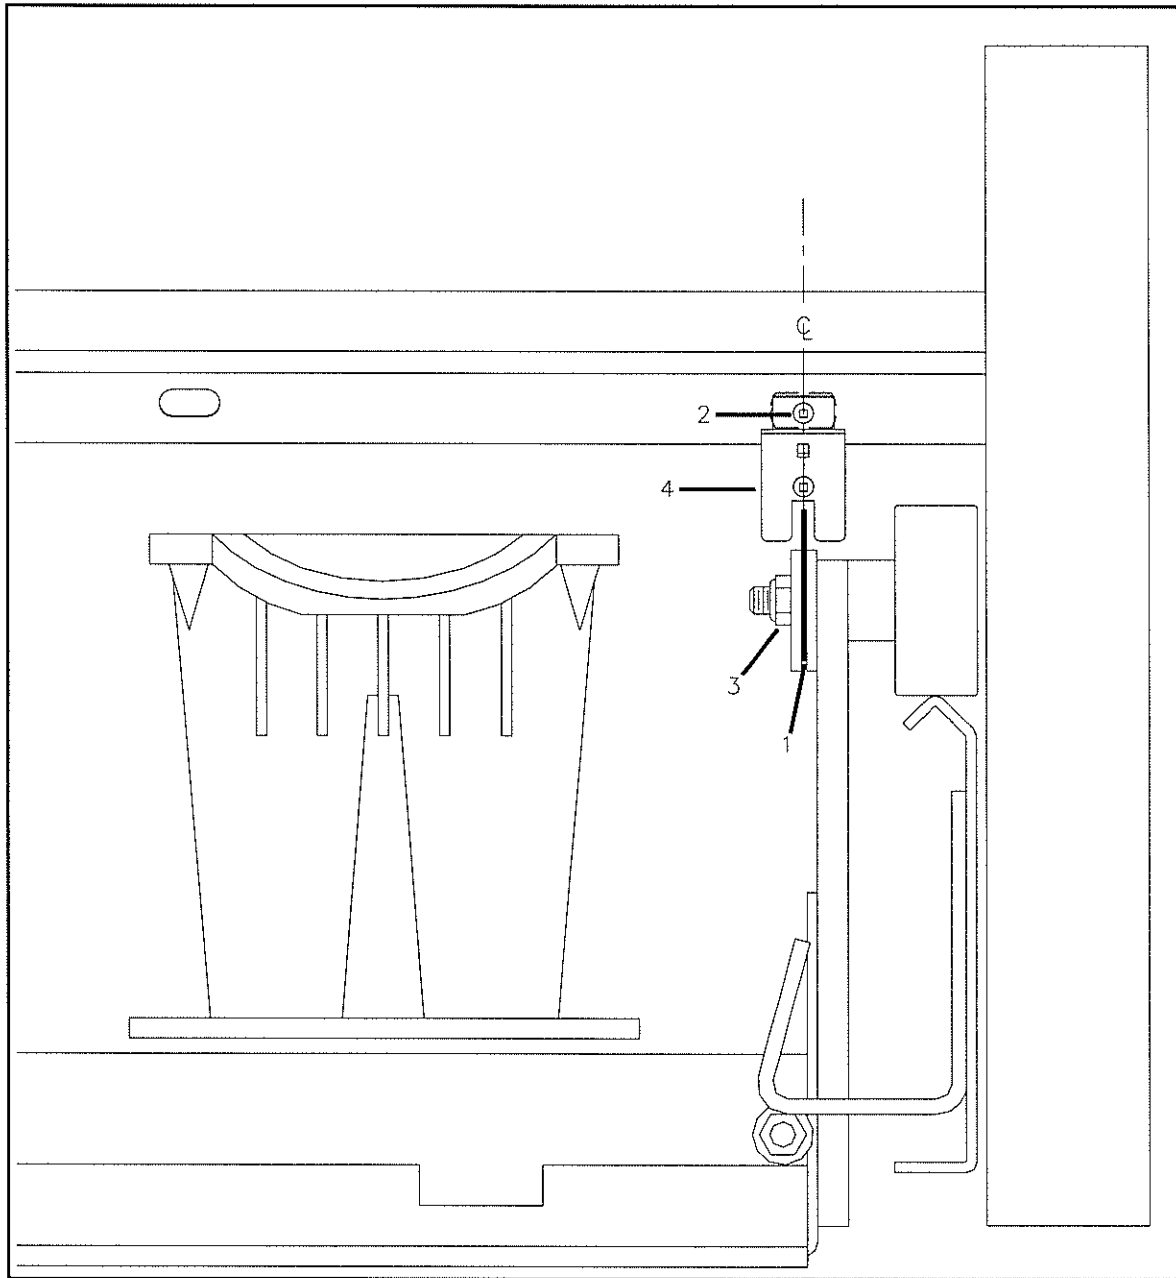
Fenix Service Bulletin Number MM-007B

The drawer's back limit optical sensor and actuator, if badly adjusted, may cause unnecessary "DRAWER SPI COM TROUBLES".

To avoid this problem, the drawer's back limit optical sensor must be kept centered with its actuator as explained in adjustment 8G. Place the drawer in its rear position, loosen either the nut, which holds the actuator, or the bolt, which holds the sensor, and adjust the two components until perfectly aligned.

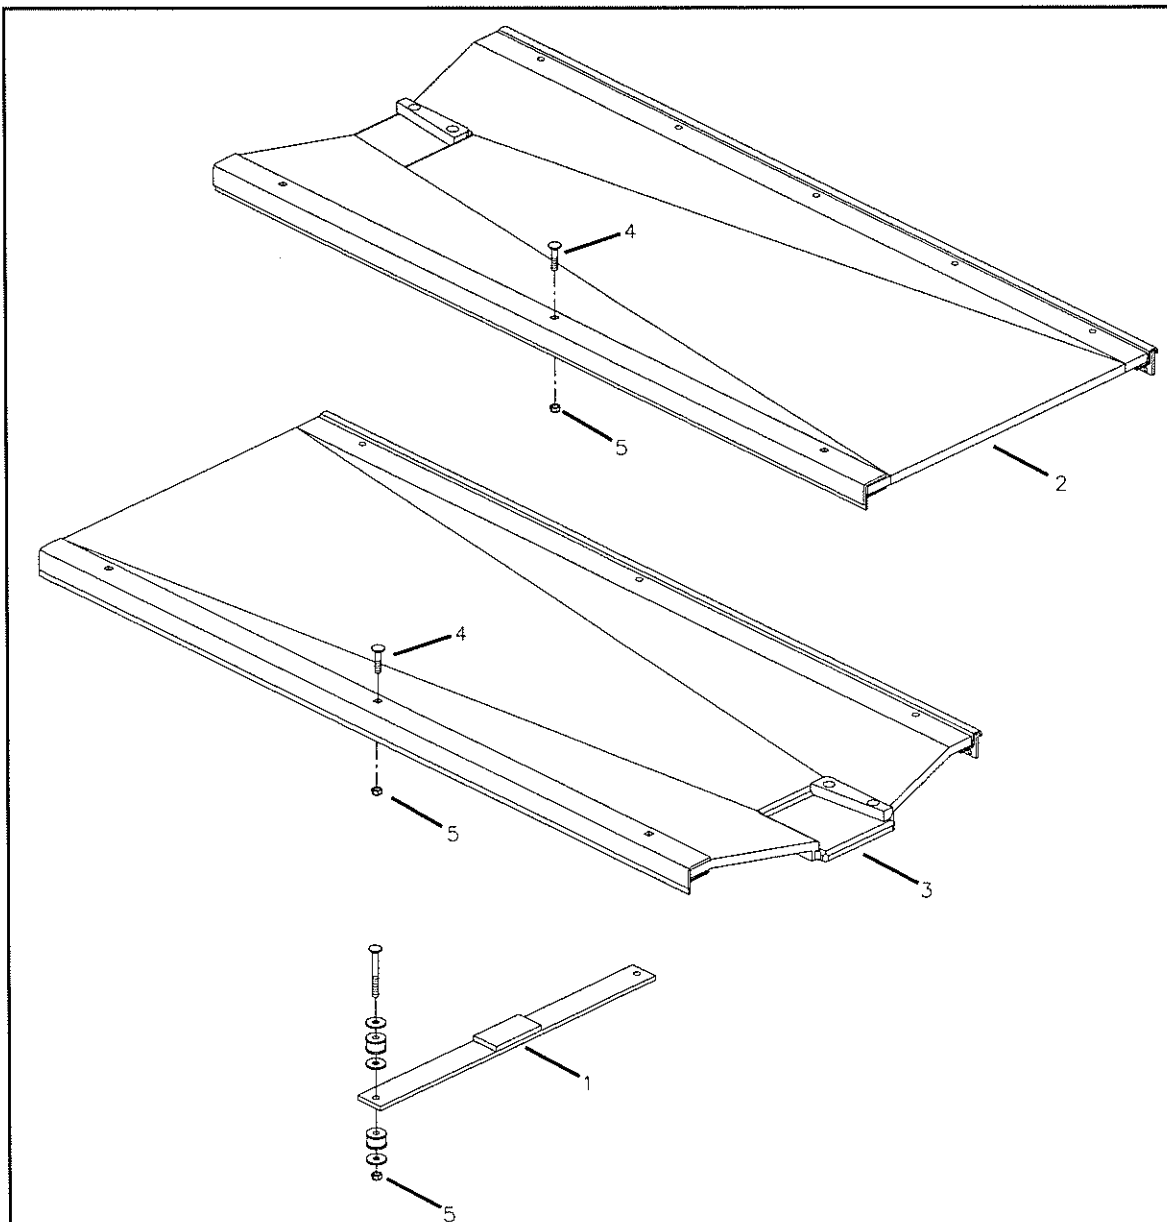
Fenix Service Bulletin Number MM-011

The constant impact and the violent shocks caused by the bowling ball falling on the pit table eventually breaks the bolts used to fasten the center supports.

If you have broken bolts at this location, remove the pit table center supports and corresponding hardware. Replace the 2-1/2" carriage bolt you removed with a 1-1/2" one. Fasten the bolt in place using the existing nylon nut.

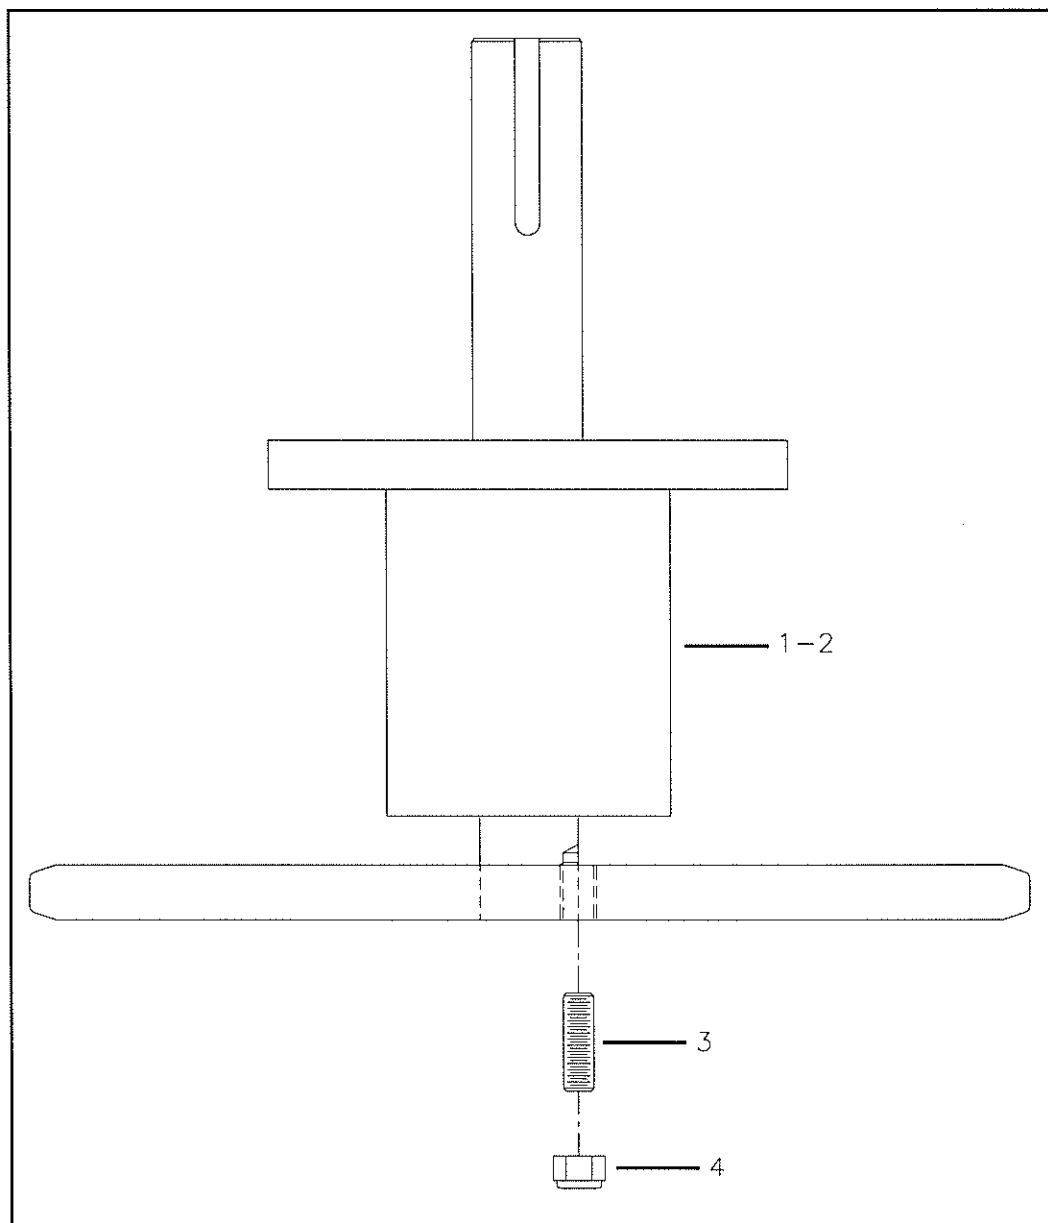
Fenix Service Bulletin Number MM-012

Starting with MM-2001 pinsetter serial number MMP-00787, the carrousel sprockets have been modified from their original design in order to rectify the small problem caused by the set screws becoming loose. The complete sprocket assemblies retain the same number since they remain compatible with the older models. It must be noted that some of the individual parts which make up the complete assemblies have changed. The new carrousel sprockets parts listings will be in the third edition of the MM-2001 Pinsetter Service Manual.

If you have the older model sprockets, simply verify that the set screws are still solidly engaged in place. Remove any loose set screws and replace them with longer ones as shown on the flip side of this bulletin. Make sure that all set screws replaced are treated with a removable thread locker¹, such as Loctite 242. Lock the new set screw in place using a nylon nut.

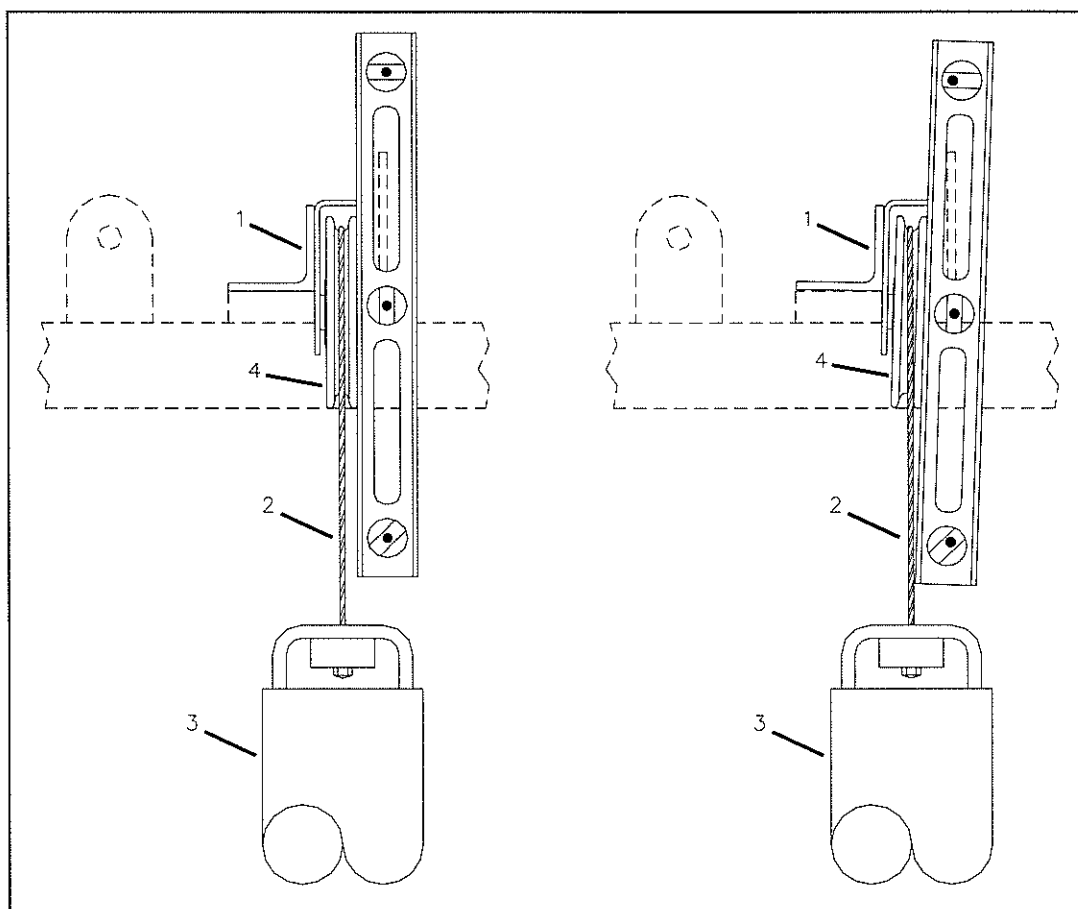
Fenix Service Bulletin Number MM-015

The constant movement and considerable weight of the deck load eventually causes the U-shaped bracket which supports the pulley to bend out of shape.

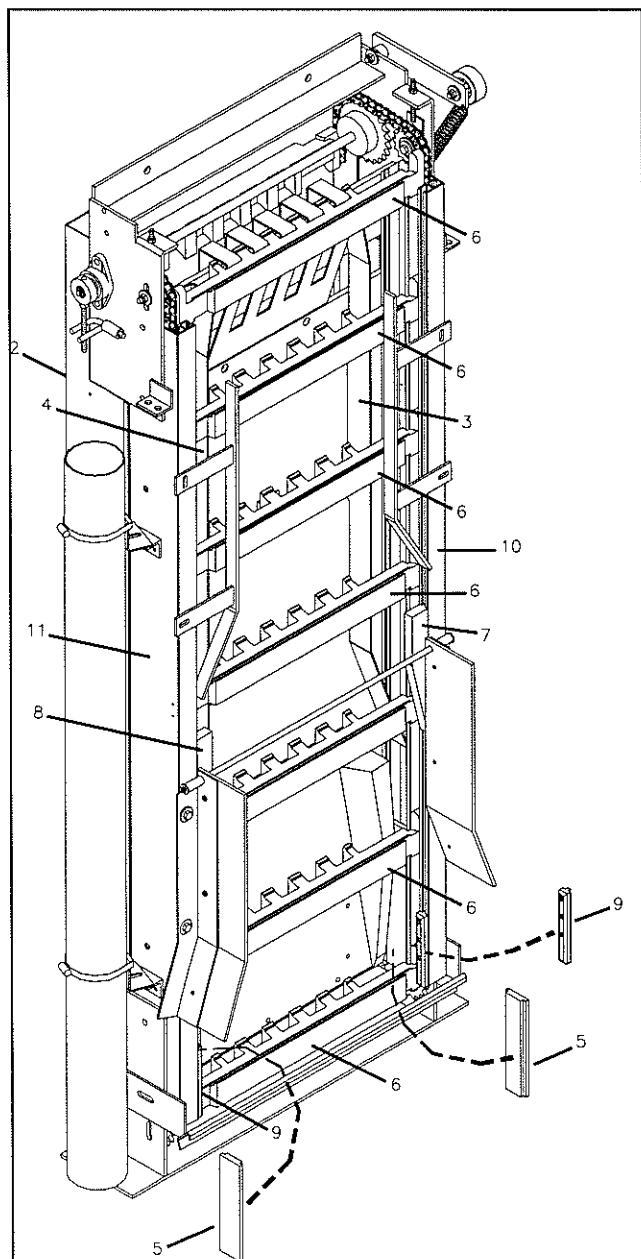
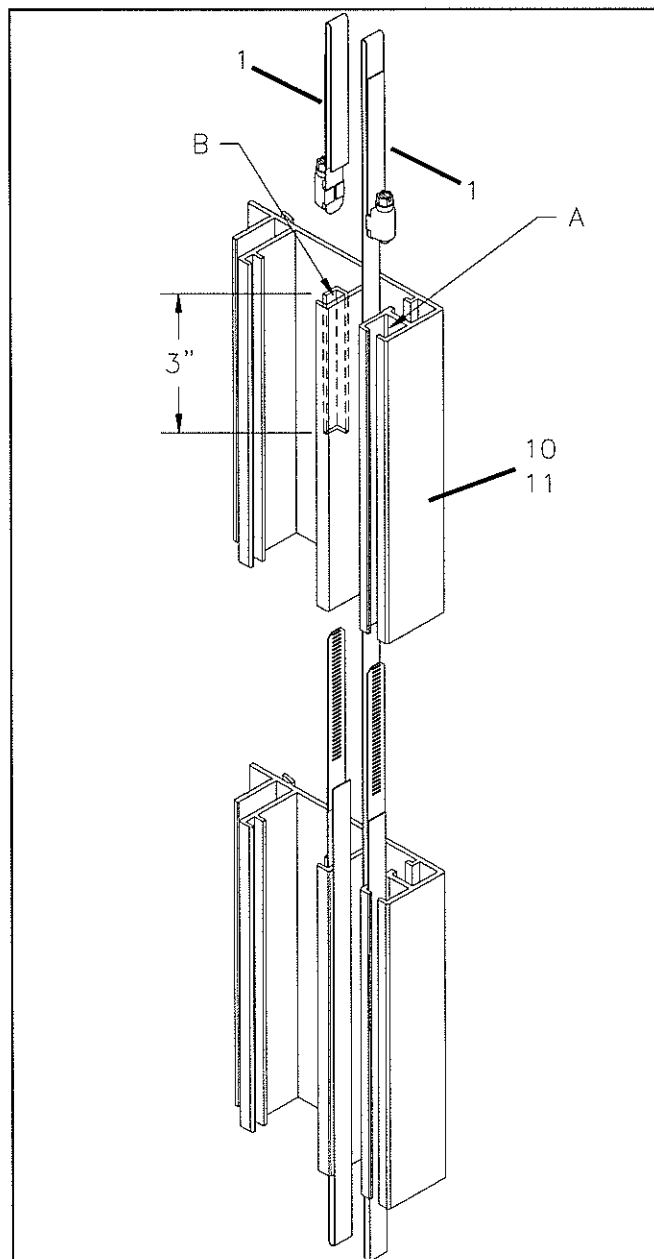
Subject to different degrees of friction from the pin lift arms (303-8020-00), the elevator's 4 metal straps (302-8005-00) may eventually wear and ultimately break. Although the pin elevator will function normally without these metal straps, it is important to replace them in order to protect the aluminum tracks from the constant movement of the drive chains. When replacing these metal straps, it is not necessary to replace all 4 at the same time. You may replace only the broken strap, but it should be noted that since this is not an easy procedure, you should take advantage of the fact that parts have been removed from the pin elevator. With these parts removed, you may want to verify the other straps and replace them if you judge that they too will break on a short-term basis.

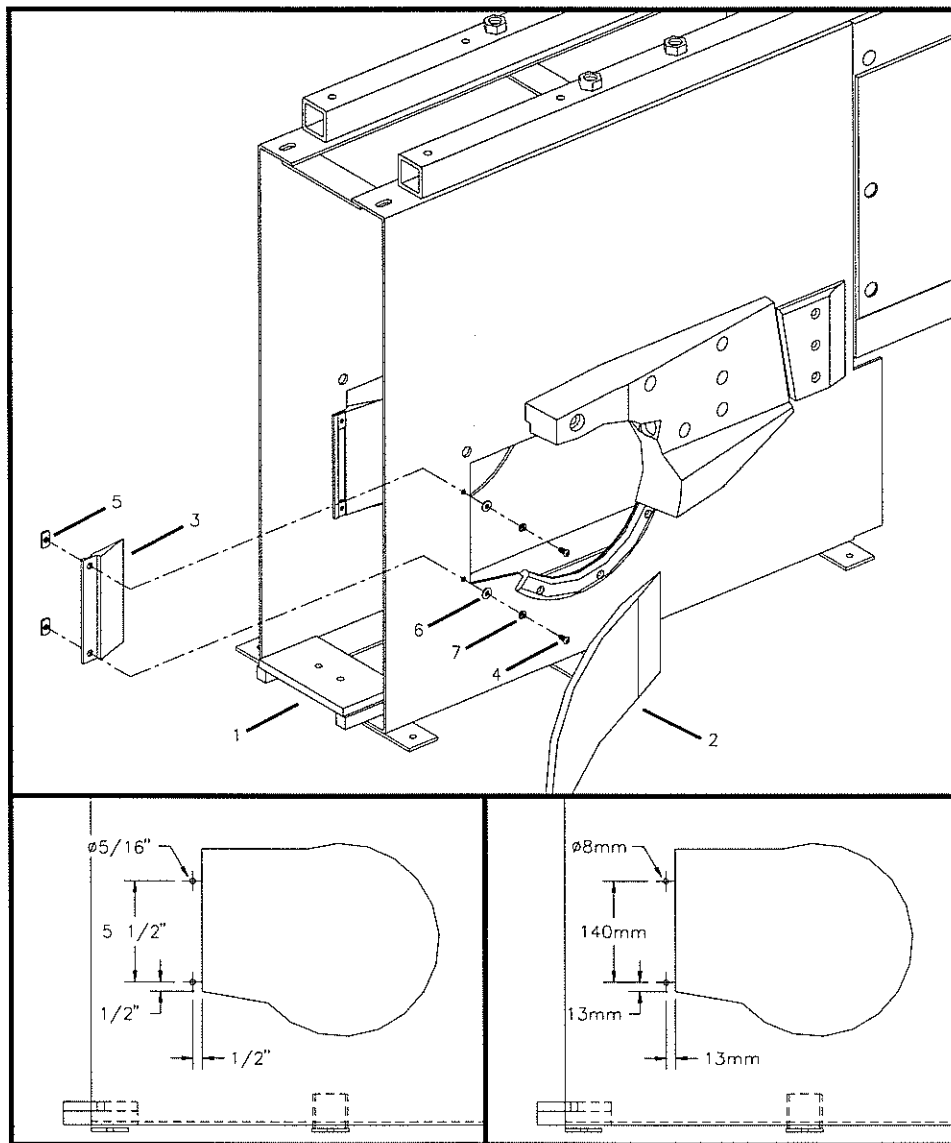
Figure 1

The wearing of the pit deflector (303-6330-00 & 303-6335-00) will cause pins to stay in front of the ball door when a ball needs to exit. This will result in a longer time to get the ball out of the pinsetter and back to the bowler.

N.B. : When performing this modification, you **must** replace the 2 old pit deflectors with the 2 new pit deflectors included in the modification kit.

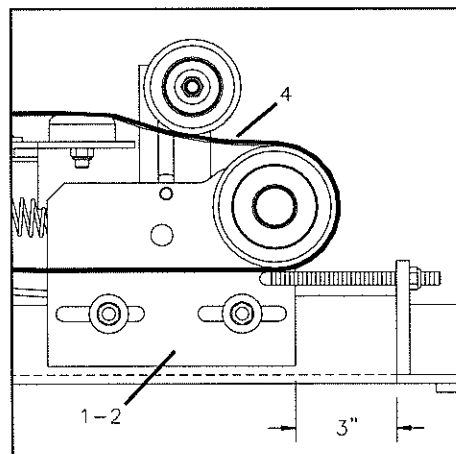
Figure 1

Failure to adjust the conveyor belt properly will result in slower time to return the ball to the bowler and in some circumstances, a premature wearing of the conveyor belt itself.

THE DISTANCE FROM THE PIT FRAME AND TENSION PLATE SHOULD ALWAYS BE MAINTAINED BETWEEN 3" AND 3-3/8".

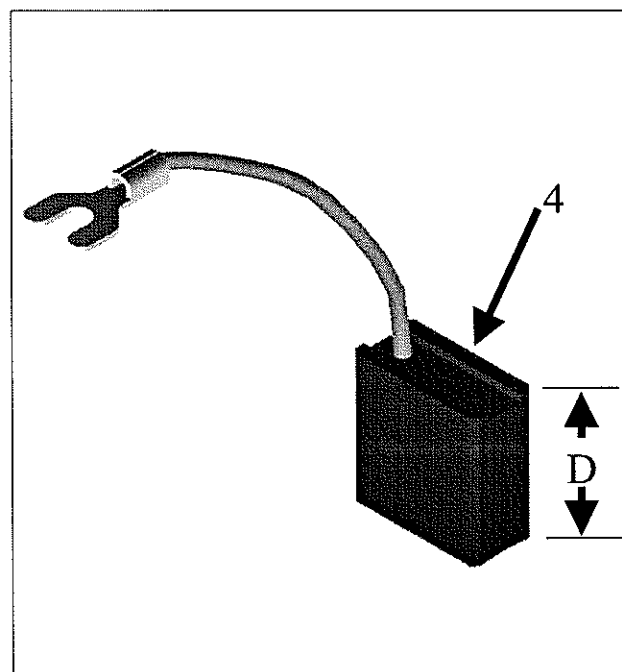
Figure 4

After replacement of the drawer motor or the deck motor, one of the following message is displayed on the Controller Magnet 2001: **DECK TROUBLE** or **DRAWER TROUBLE**. When the motor was removed, the dust from the motor brush shifted within the motor. This is keeping the motor from working properly by limiting the contact between the motor brush and the driving shaft. This has the consequence of lowering the pressure on the motor brush, creating power losses to the motor.

P.S.: Use this opportunity to check the motor brush for wear. The minimum length for the motor brush is 1/4"(6.5mm) (Figure 4, Item D). If the motor brush is shorter than this measurement, proceed to the replacement of the **TWO** motor brushes.
