MM-2001 PINSETTER

**Adjusting the pin elevator drive chain.***December 1995 (revised February 2003)*

Fenix Service Bulletin Number MM-001

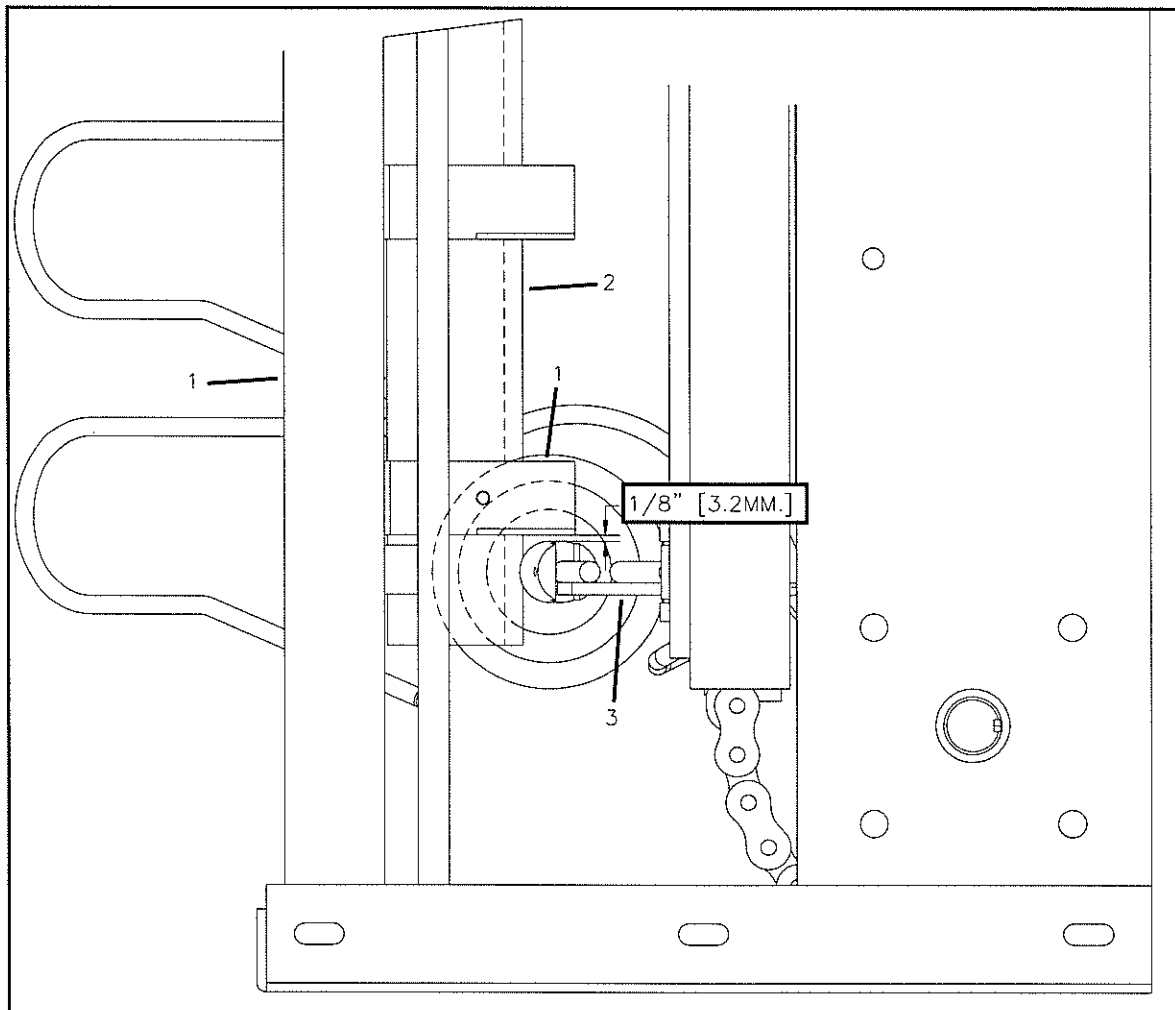
Fenix Service Bulletin Number MM-007A

An efficient grounding system is integrated with all of the MM-2001 pinsetter components. If your equipment is not properly grounded, the central processing units [CPU] can literally blow their electronic chips when they receive a static electricity discharge, be it from bowlers or a defective part.

Keep the drawer's guide rollers and slides clean in order to avoid buildup and eventually cause damage to the pinsetter's electronic components.

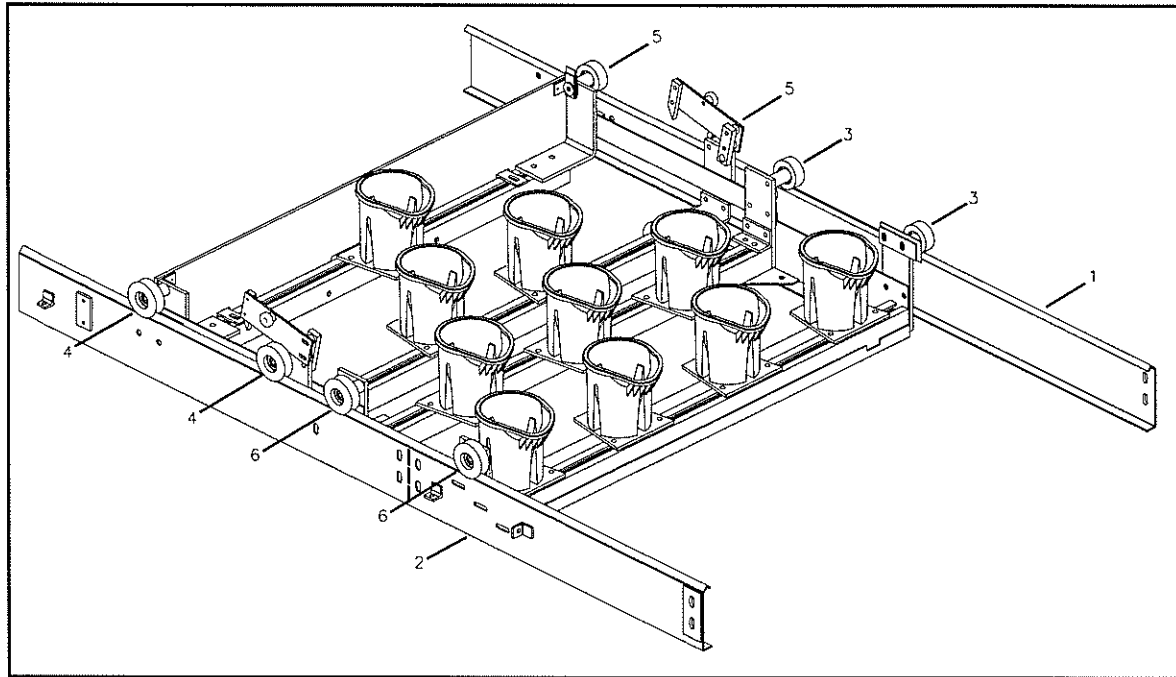
The drawer's back limit optical sensor and actuator, if badly adjusted, may cause unnecessary "DRAWER SPI COM TROUBLES".

To avoid this problem, the drawer's back limit optical sensor must be kept centered with its actuator as explained in adjustment 8G. Place the drawer in its rear position, loosen either the nut, which holds the actuator, or the bolt, which holds the sensor, and adjust the two components until perfectly aligned.

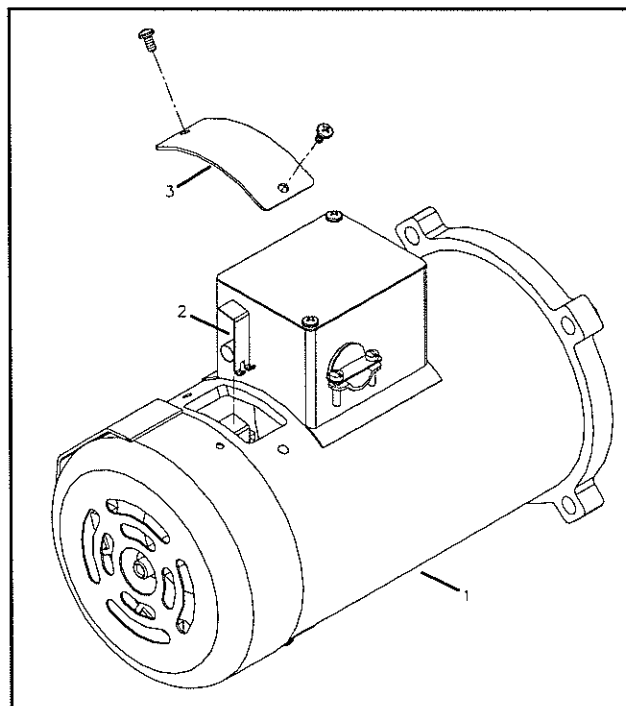
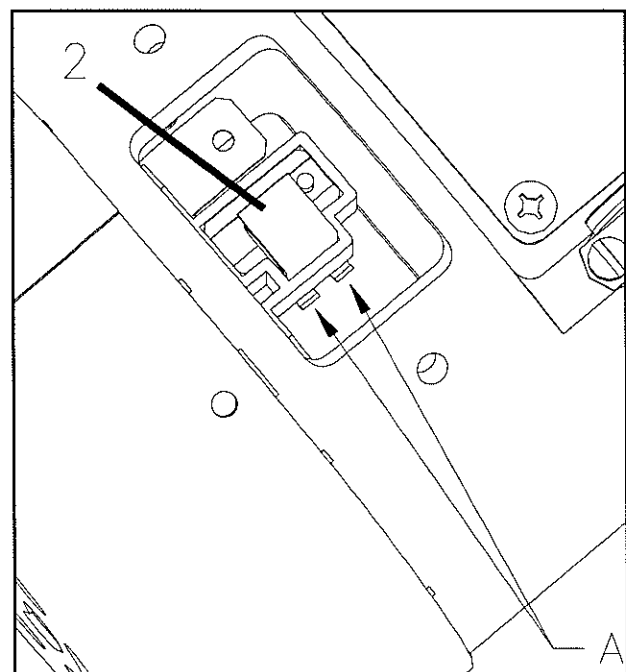
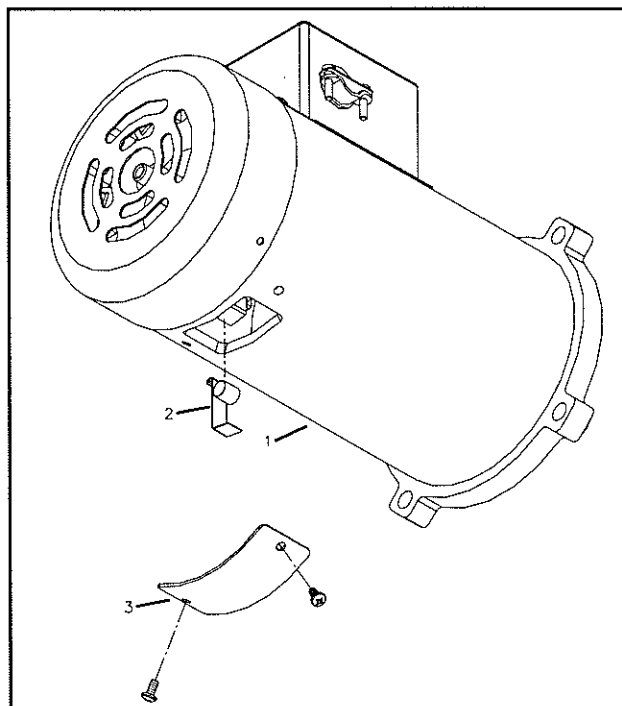
P.S.: Use this opportunity to check the motor brush for wear. The minimum length for the motor brush is 1/4"(6.5mm) (Figure 4, Item D). If the motor brush is shorter than this measurement, proceed to the replacement of the **TWO** motor brushes.

Cleaning process for the motor: Shut down the pinsetter and remove the twist lock connector from the power box. Open the two metals covers (Figure 1 & 2, Item # 3) and unlock the two spring clips (Figure 1, 2 and 3, Item # 2). **Before removing the motor brush**(Figure 4, Item # 4), **take note of the brush orientation inside the conduit.** Then remove the two motor brushes slowly. Clean the motor by blowing compressed air inside the motor brush conduit to remove the dust. Turn the motor with the deck crank(Z-ME4100) and restart the process with compress air until the dust is no longer coming out of the motor. Re-install the motor brush (in the same orientation), the spring clips and the motor covers.

To lock the spring clips in place, press down on the spring clip and release it in order to have the two hooks (Figure 3, Item A) engage under the metal plate.

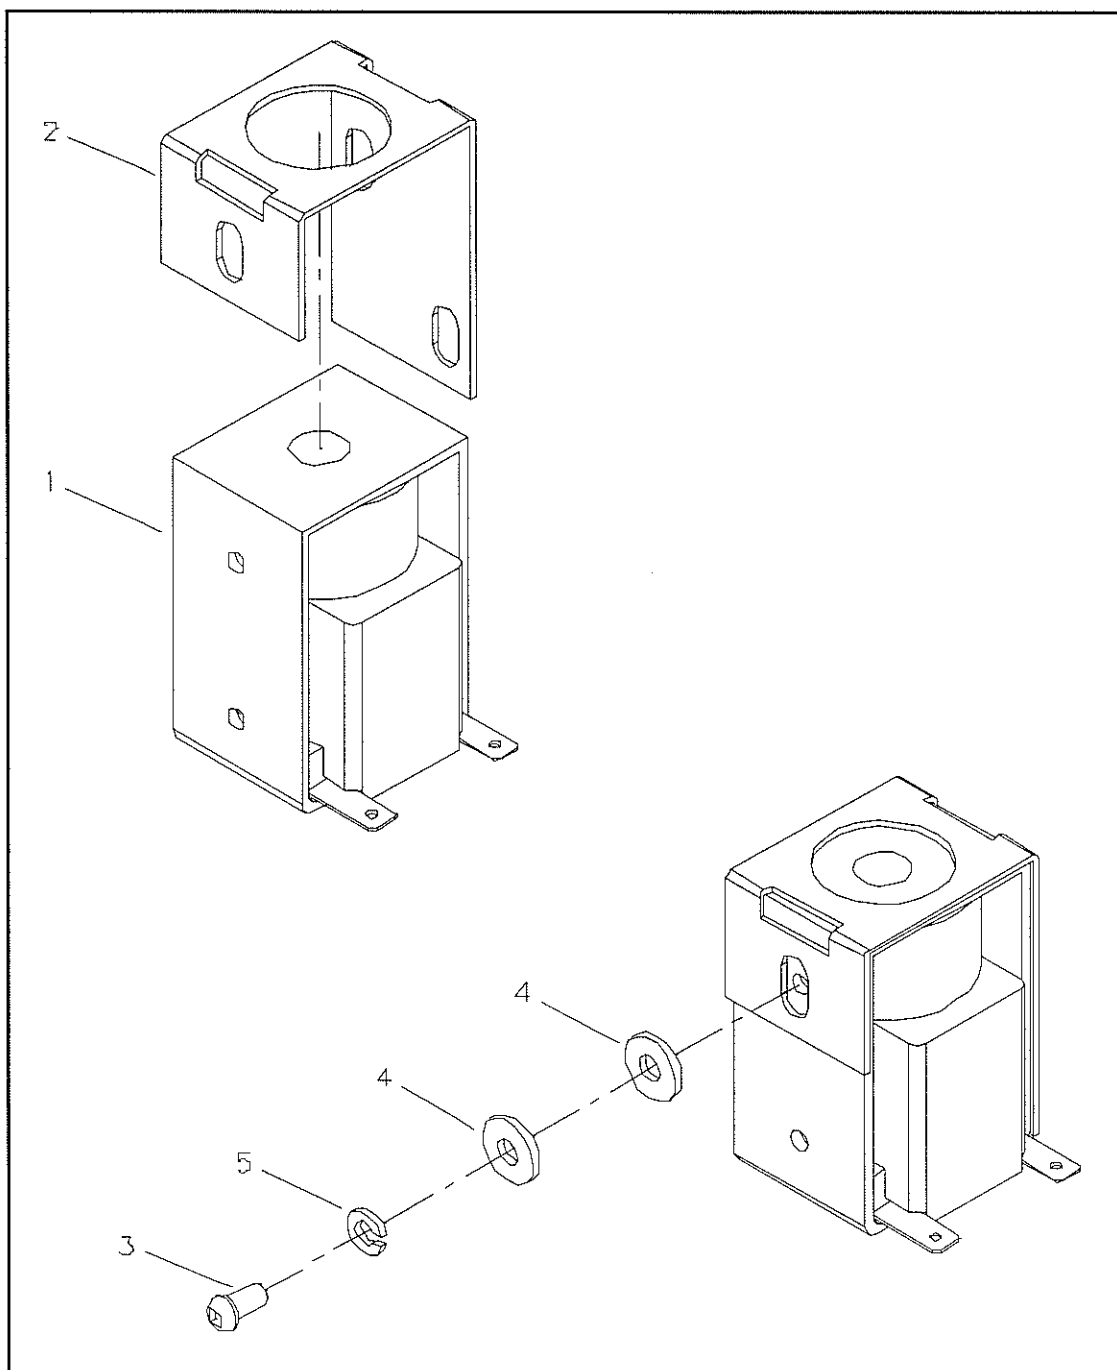
Mendes Service Bulletin Number MM-037

- When installing, it is absolutely necessary to use two flat washers (7016-410632-025) and the lock washer (7060-006046-003) according to the included diagram. Failure to do so may damage the solenoid unit.
